# SIMPSON HUMBOLDT OCEAN OUTFALL MULTIBEAM BATHYMETRIC SURVEY AND VIDEO INSPECTION HUMBOLDT BAY, CALIFORNIA

## **Field Operations Report**

> CE Reference No. 15-09 5 November 2015

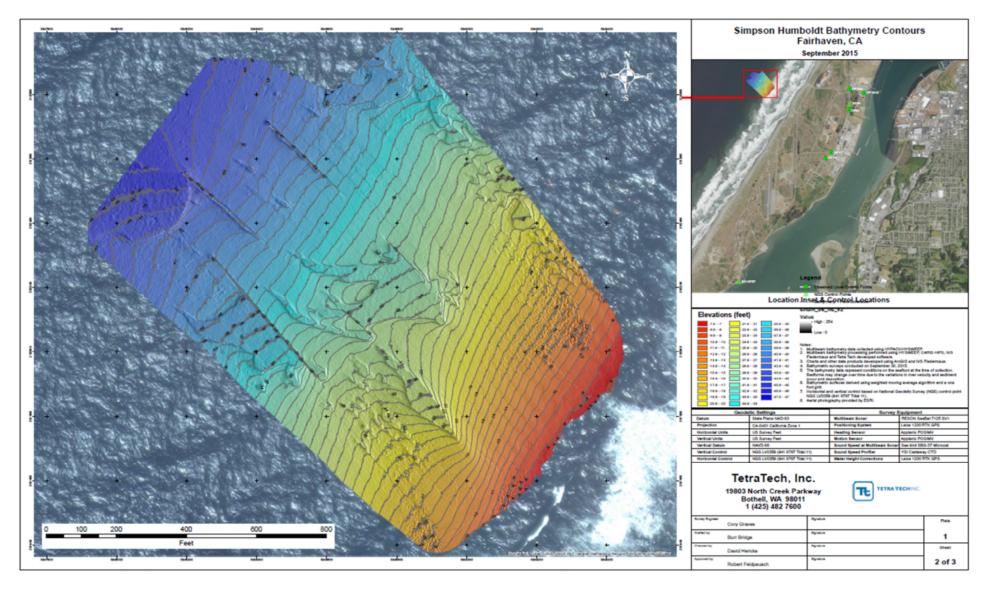
Figure 1-1. Map showing the Simpson Humboldt Bathymetry Contours Fairhaven, CA.

A shallow bathymetric survey offshore of Humboldt Bay was needed to assess the location and determine the condition of the ocean outfalls at the former Simpson mill location in Humboldt Country near Fairhaven, California.

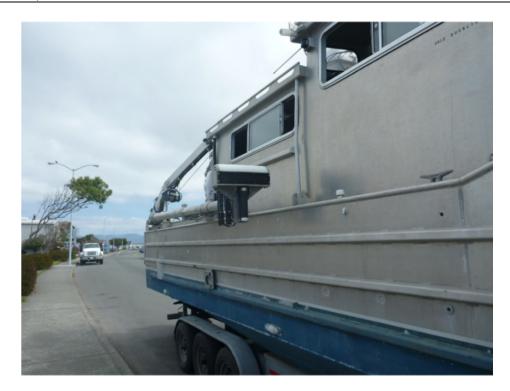
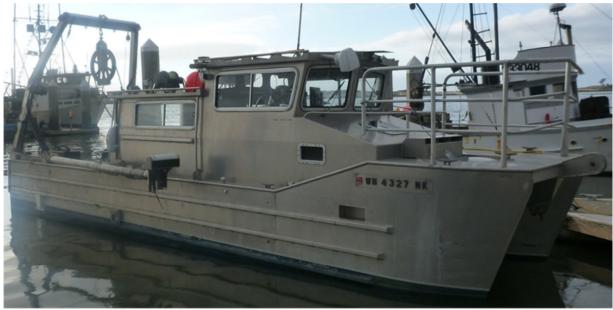
Figure 2-1. Above is the RESON 7125 Multibeam Echosounder on Vessel UGLE DUCKLING; Below is a view of the vessel UGLE DUCKLING in the Eureka, CA marina.

The *Ugle Duck*, a 35-foot-long multibeam survey vessel, was used as the survey vessel for the project (Figure 2-1). The vessel was equipped with the following primary equipment for execution of the survey:

- 1. RESON 7125 SV1 MBE (400kHz) multibeam echosounder with a dual frequency system (200/400 kHz), utilizing 400kHz for the purpose of this survey.
- 2. Video Ray Pro4 Inspection ROV.

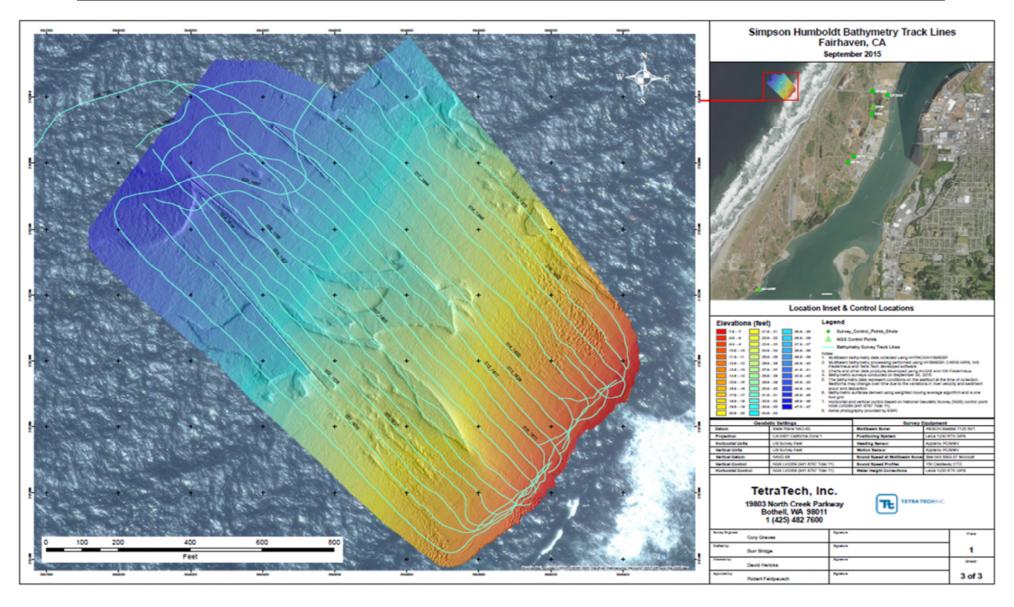
Figure 2-2. Survey vessel track lines for the multibeam survey performed September 2015.

The objective of the survey was to acquire multibeam data to assess the location and determine the condition of the ocean outfalls at the former Simpson mill location in Humboldt County near Fairhaven, California. Twenty-two parallel lines provided continuous bathymetric coverage within area of the ocean outfalls. Due to the sea conditions and shallow depths curves were runon the start and end of the tracklines lines, therefore the endpoint coordinates were related to these and not on the actual planned lines submitted with the pre-survey notification.

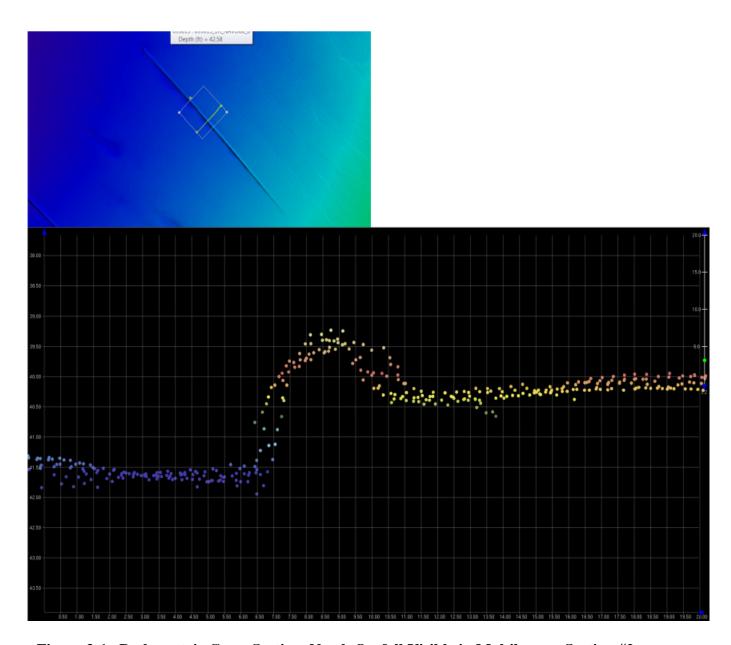
Figure 3-1. Bathymetric Cross Section, North Outfall Visible in Multibeam - Section #2 - Length 322.05'

The results of the multibeam survey for selected transects are shown in Figures 3-1 through 3-3.
